DERWENT & HOWDEN RESERVOIRS

**GATE VALVE REPAIR CONTRACT
ORDER NUMBER JBVS 0526
Work carried out 2005/2006**

Jbvs 0526 Derwent West - inspection of valve S4

Record of repairs carried out on the Automatic scour Valves at Derwent & Howden Reservoirs between September 2005 and March 2006

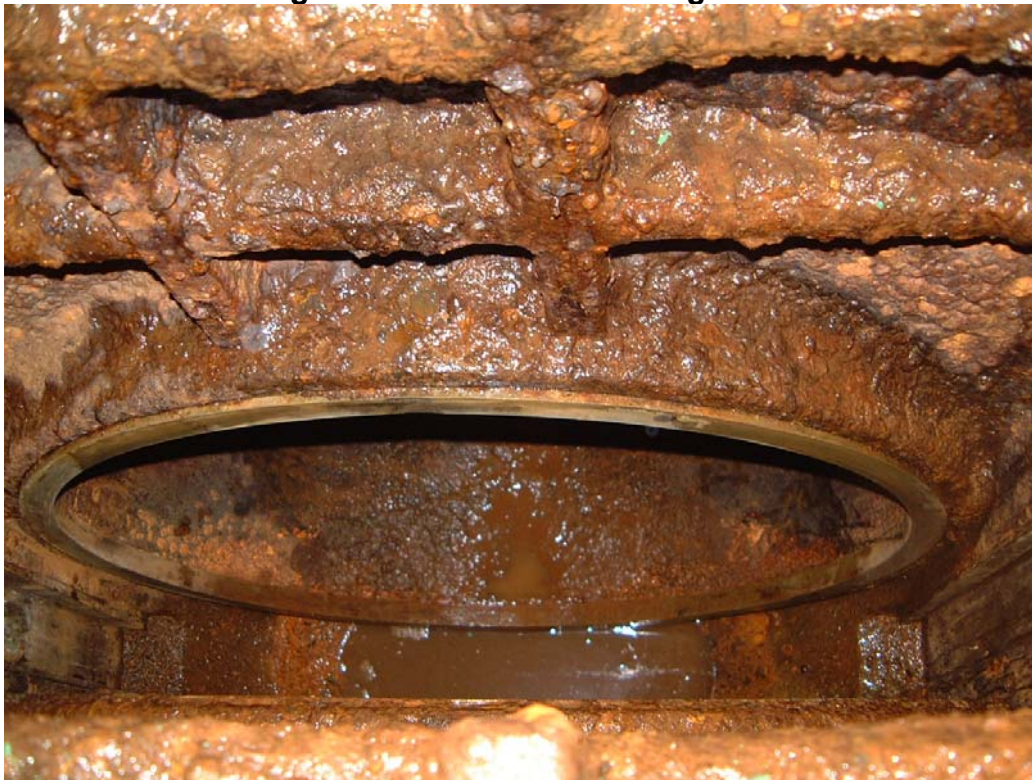
Ref number 20

Internal, minor surface corrosion. The downstream bore at 20 – past through to 20 – to, has corrosion and cavitation damage.

View showing the downstream seat ring and outlet bore

Repair cavitation damage to the outlet bore as per the contract specification

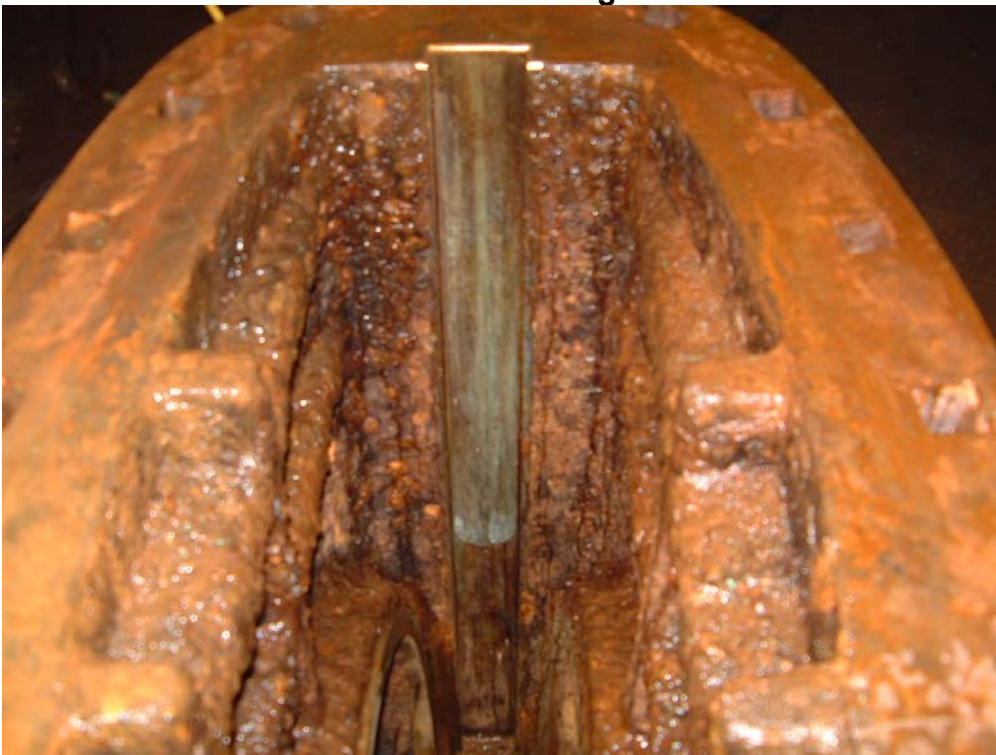
Ref number 18

Both guides are in good condition, no steps or obvious visual deterioration has taken place.

General view of the channel guides R/H Side

Clean up remove any scoring and bruising.

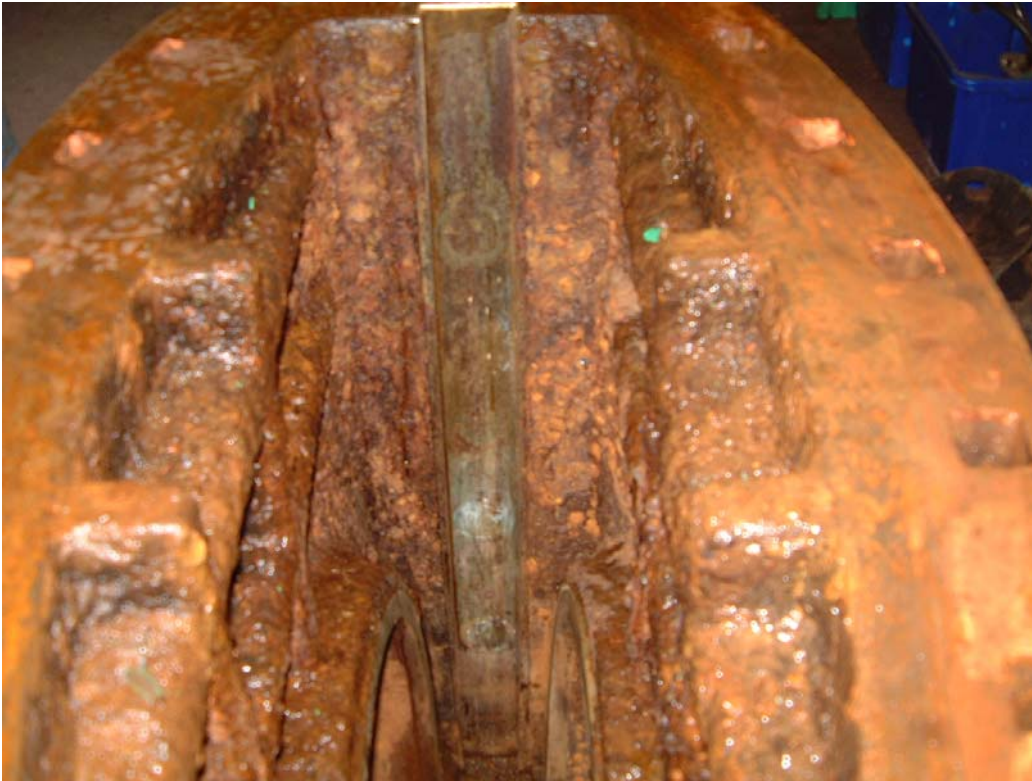
Ref number 19

General view of the channel guides L/H Side

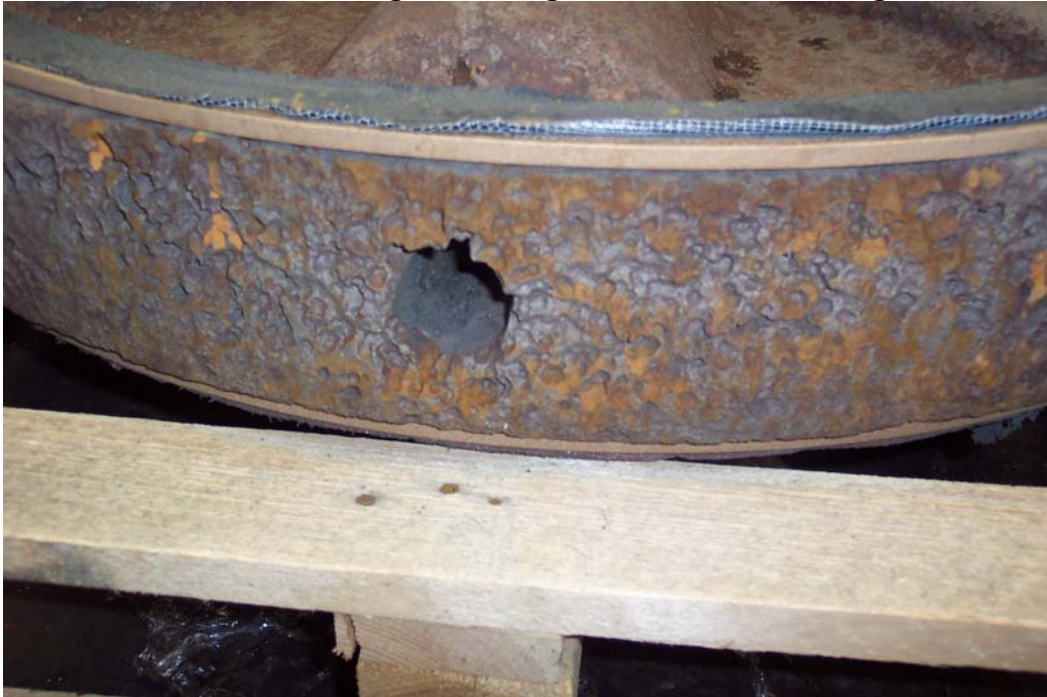
Ref number 100-1265

The condition of this Wedge has deteriorated since we carried out the inspection in 2003. The bottom of the wedge has suffered from corrosion/ cavitation damage.

View of the wedge showing the cavitation damage

Repair the cavitation damage to the bottom of the wedge. **(This is additional to the contract specification)** Shotblast and paint the rest of the wedge.

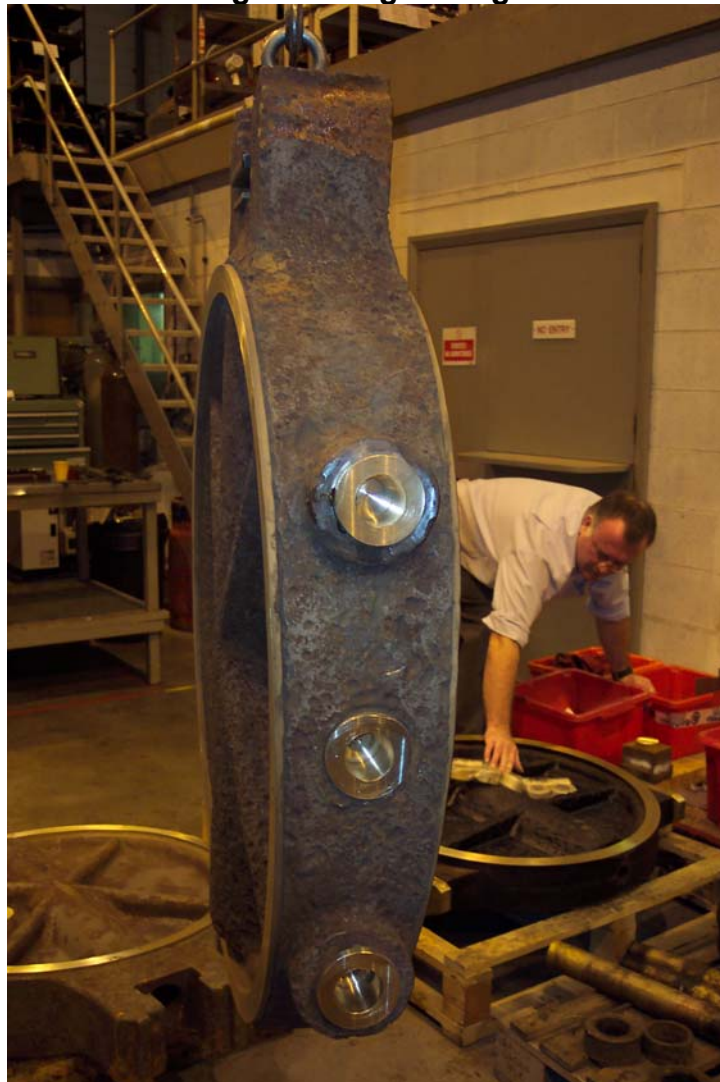
Ref number 100-1279

The top middle and bottom set were all intact; however excessive wear on the clearances was apparent.

The top, middle and bottom roller sets were all intact, again excessive clearances were apparent.

View showing the wedge and guide bushes

Replace all roller sets as per the contract specification.

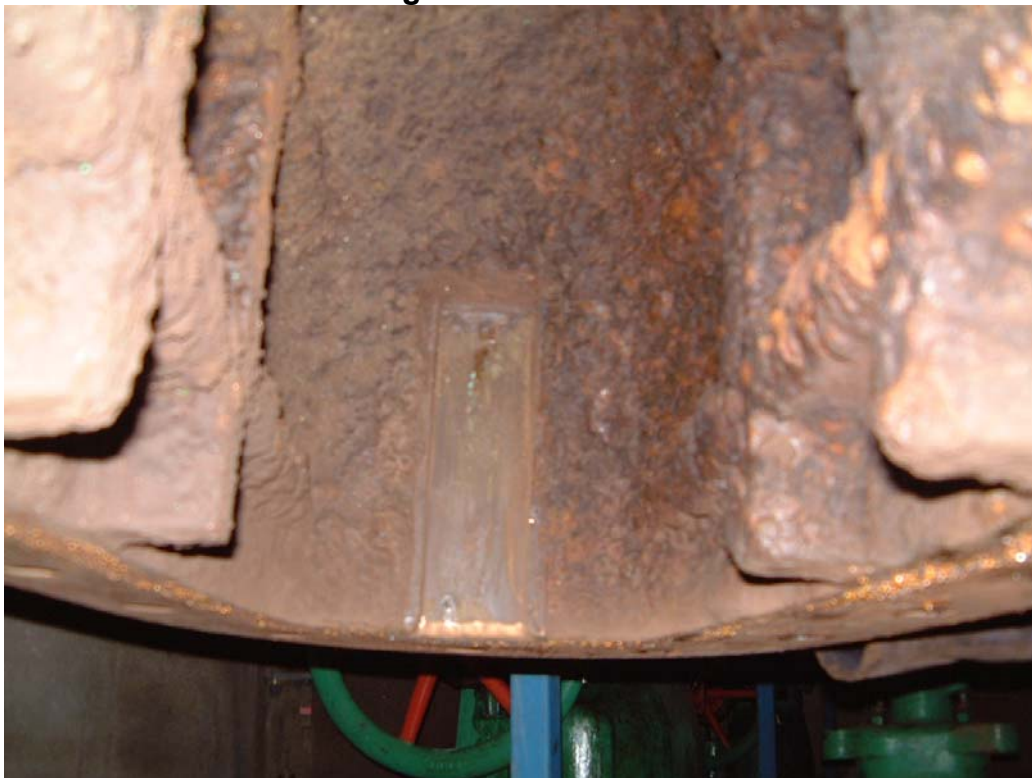
Ref number 16

View showing the Bonnet Guide L/H Side

Good condition

Clean up and grind a lead onto the edge of the guides to take up any misalignment.

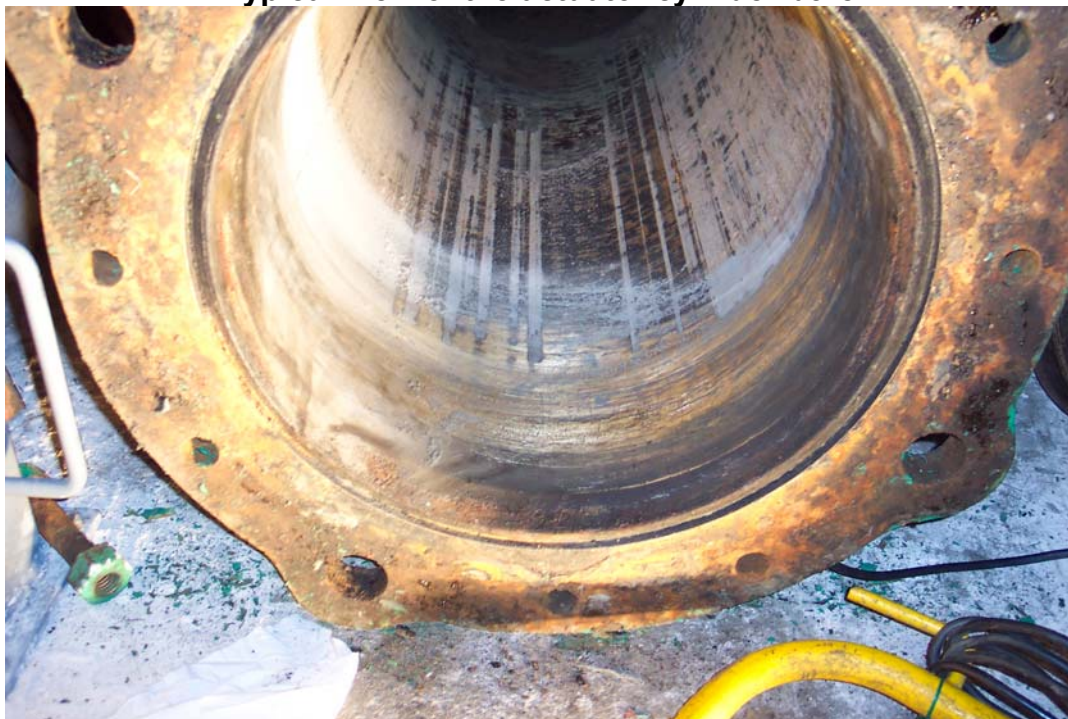
ref number 100-0392

The liner showed no loss of material due to corrosion. However, a very heavy deposit of calcite build up was on the bore.

Typical View of the actuator cylinder bore

Machine the bore of the cylinder removing any scoring as per the contract specification.

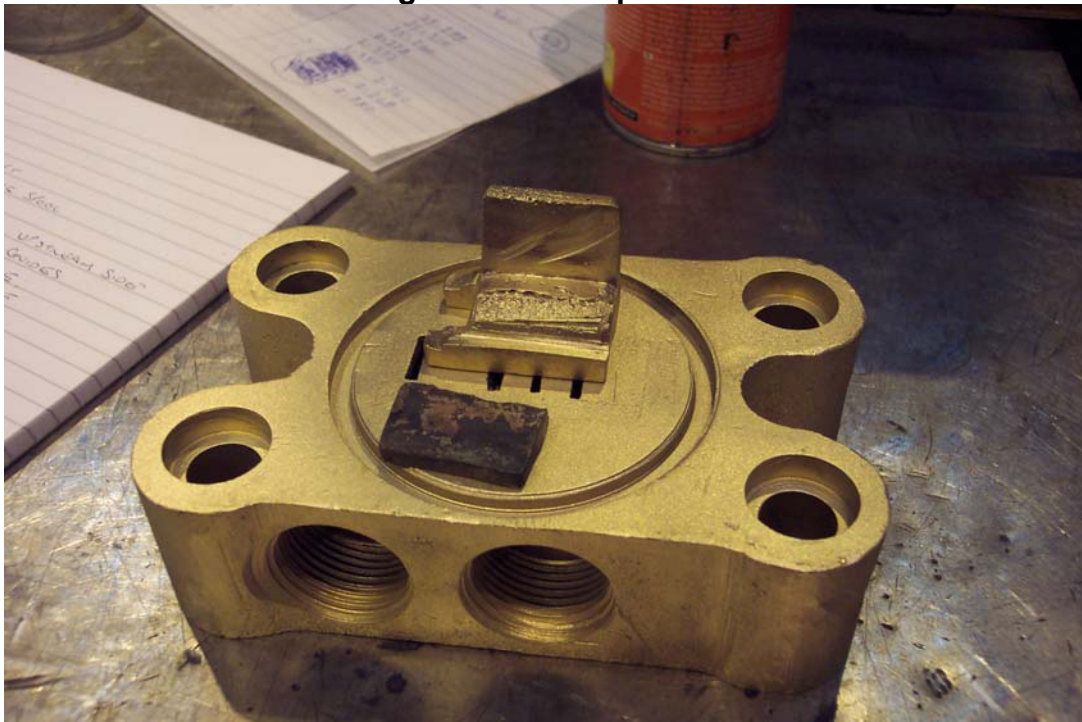
Ref number 100-1280

The thread on the operating spindle was found to be badly worn. This was contributing to the misalignment of the spool which controls the flow of the water to the operating cylinder. The actual spool valve shuttle was found in 2 pieces.

View showing the broken spool valve shuttle

Manufacture a new operating spindle and spool valve shuttle, and adjust the alignment of the port spool valve. **(This is additional to the contract specification)**

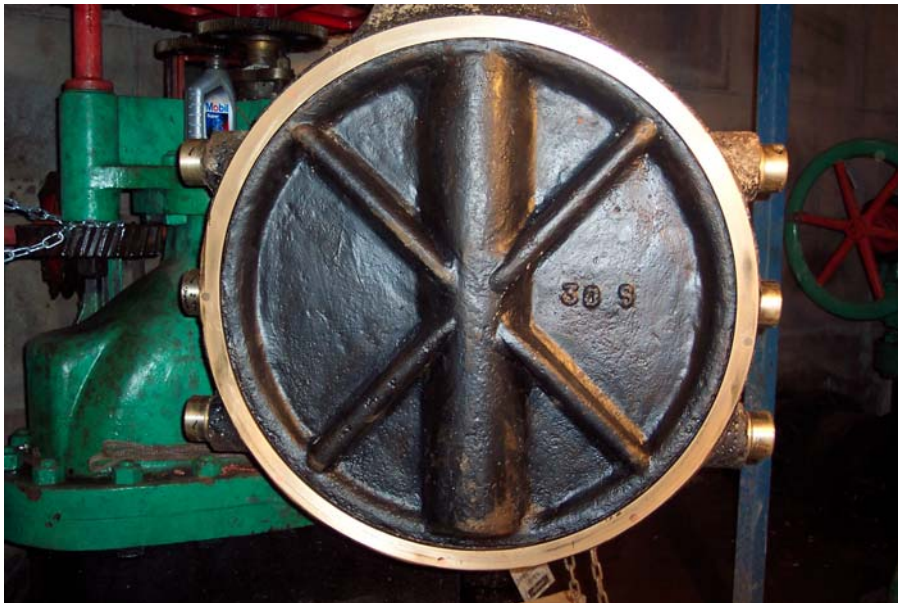
Derwent Wedge showing the new rollers

Replacement guide bushes, pins and rollers

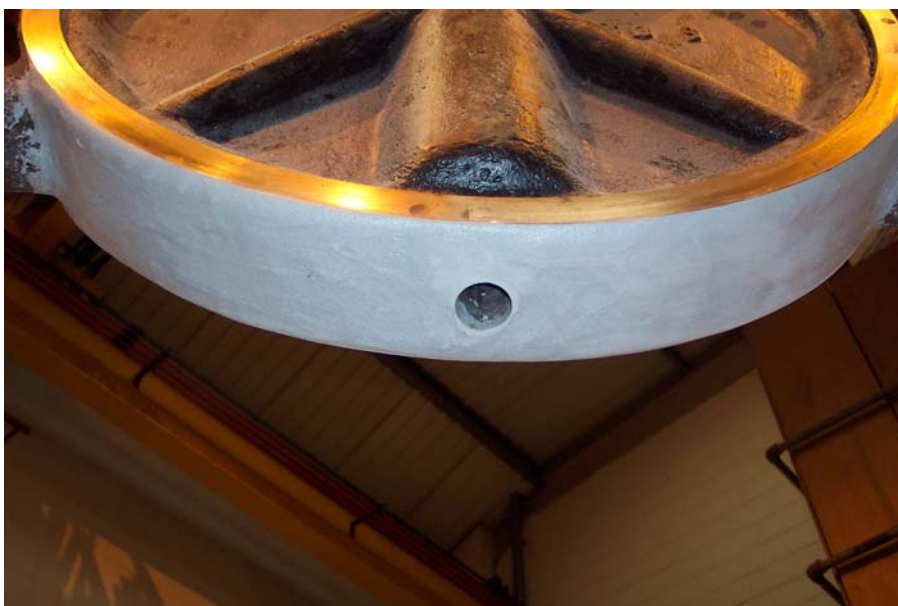
Cavitation repairs Derwent Wedge

Repairs to the cavitation damage at the bottom of the wedges

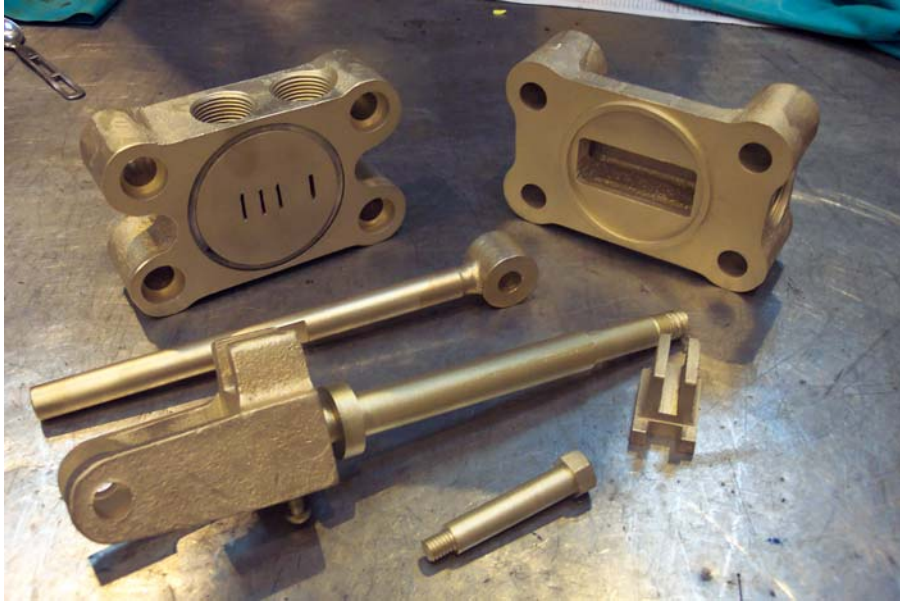
Spool valve components

Full service of the operating spool valve including the re-alignment of the internal shuttle

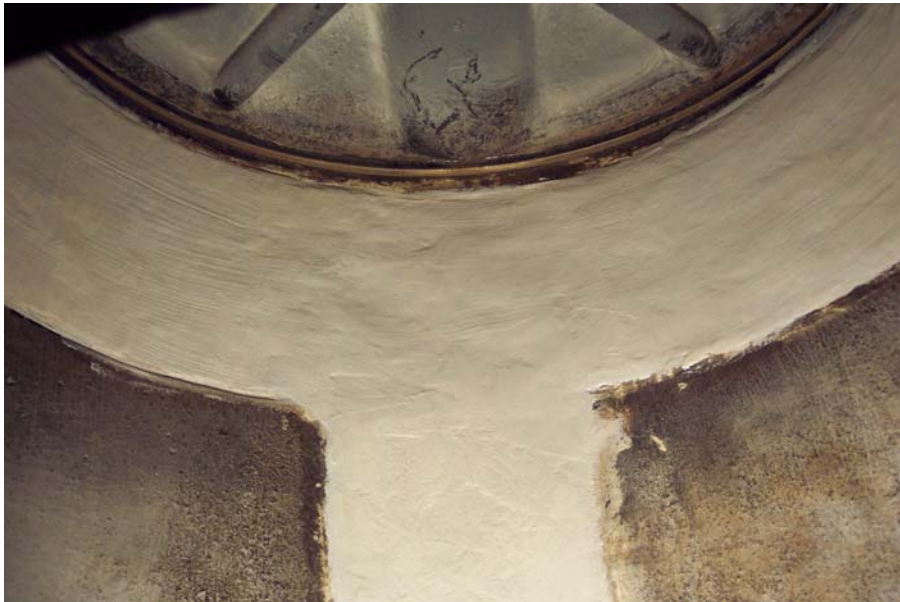
Outlet bore cavitation repairs Howden West

Repairs to the cavitation damage to the outlet bore of the bodies on S4 and S6

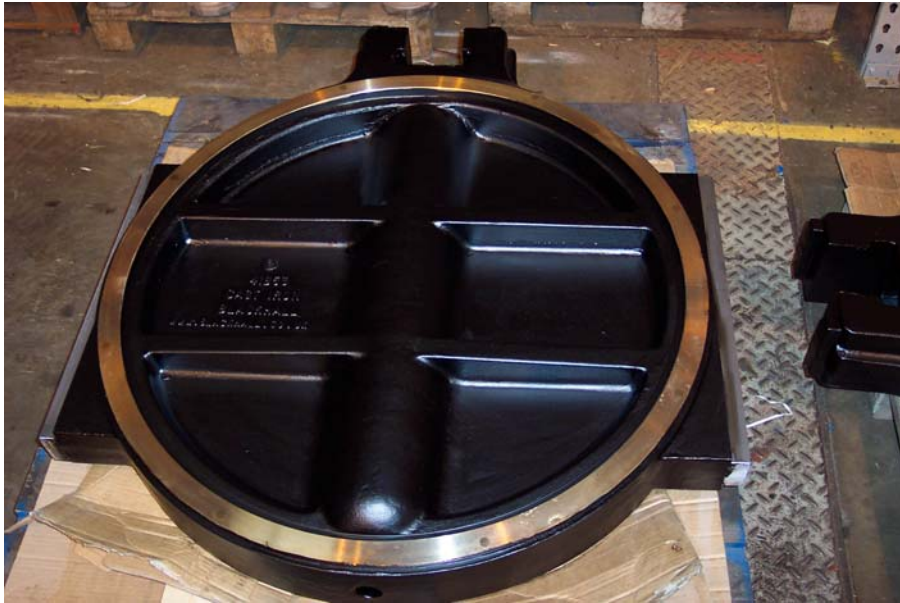
New wedge Howden West

New wedges in S4 and S6

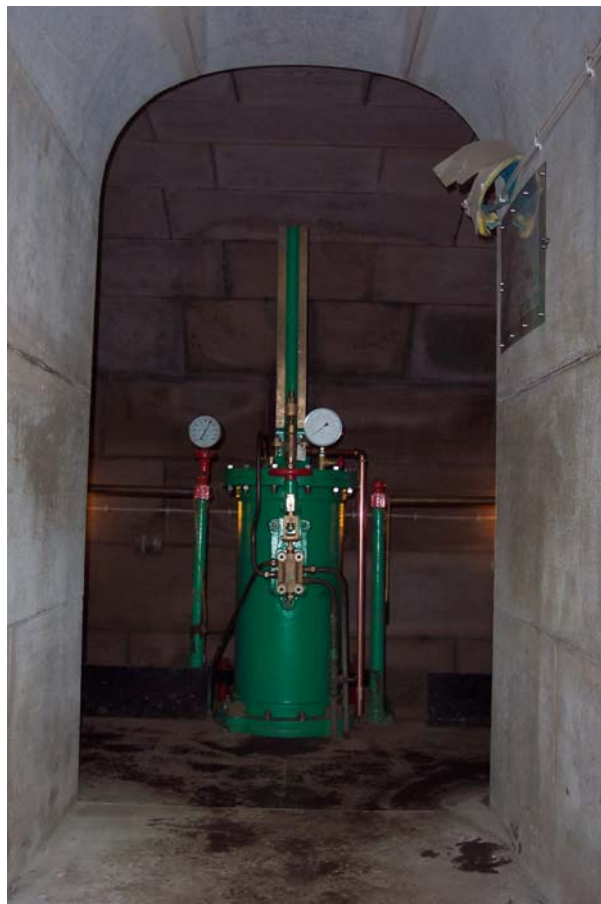
Repainted actuator Howden West

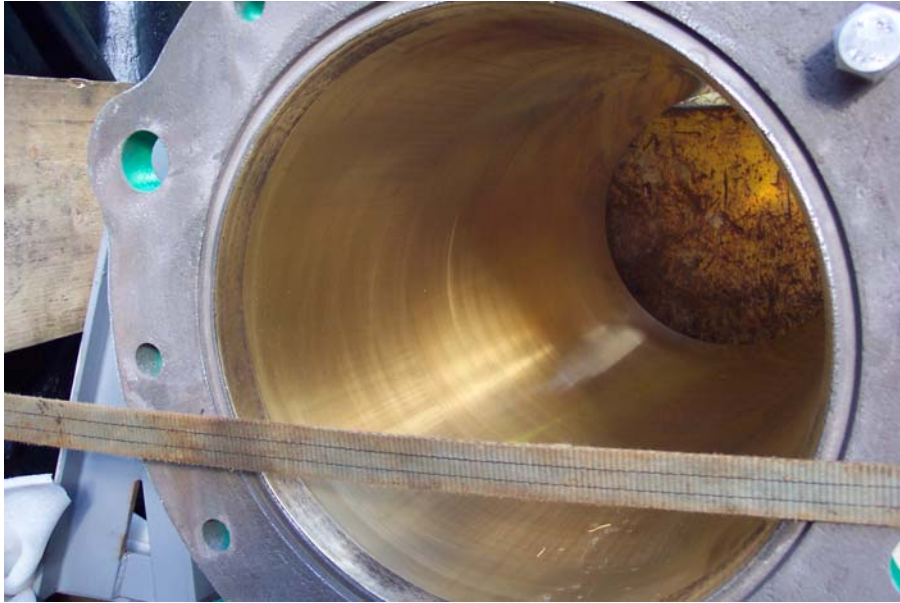
Honed actuator cylinder bore

Bore out and hone the bores on all the actuator cylinders

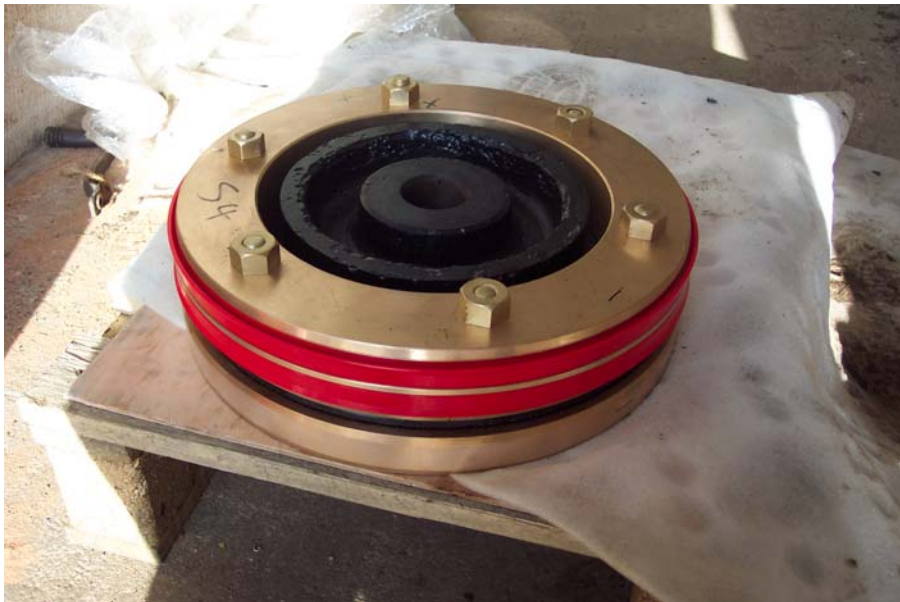
Modified piston and new seals

Modification to the actuator piston to accept the new design piston seals

New piston seals to suit oversize actuator bore (Note all the cylinder bores are different so the seals are unique to each cylinder)

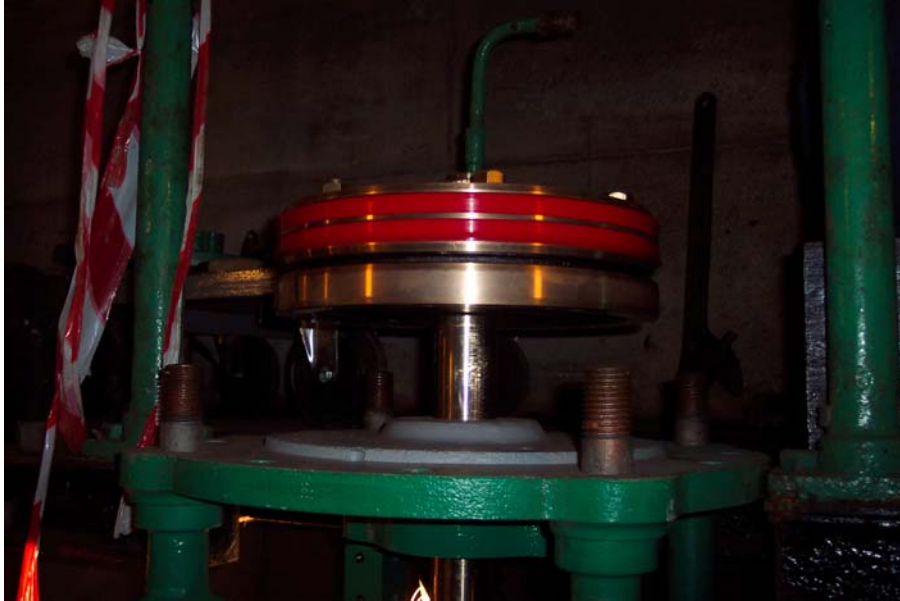
Piston assembled onto the new valve stem

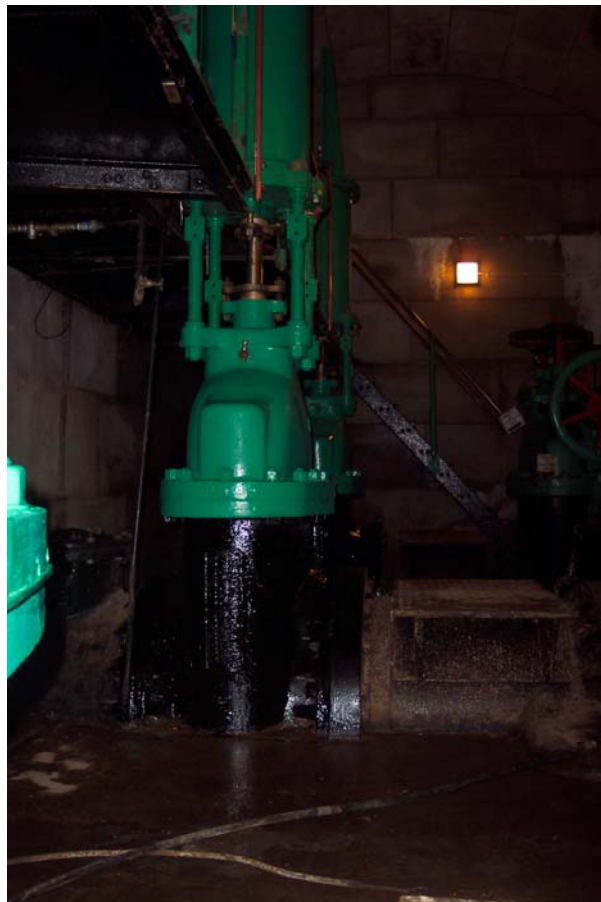
Completed valve at Derwent West
