Case Profile: Nitrification upgrade

Client: Nursing home

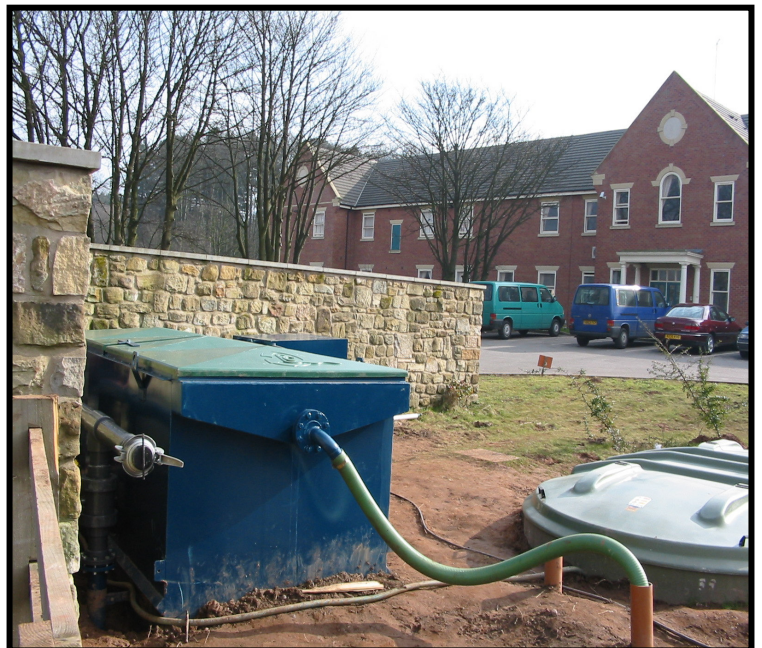
Pollution Control's Nitrification unit (shown on left) greatly enhances the nitrification process which the original RBC (shown on right) was failing on. The plant is now screened from view by conifers and bushes.

The completed nitrification plant was delivered within six weeks to a prepared excavation where the plant was buried at 2/3rds of its constructed height. The system is fitted with facilities for periodic desludging, Duty standby air supply with variable adjustment, also easy access and maintenance. We have dealt with the odour problem by scrubbing air through a filter direct from the original plant and through the nitrifying process completely eliminating any smells..

Within three weeks of commissioning the "off the scale" ammonia reading was in single figures and daily improvements have been recorded.
